Helsingborg (S) Potable water tank lining

Country	Sweden
Type	Water Tower Rehabilitation
Client	NSVA (Nordvästra Skånes vatten och avlopp AB)
Main Contractor	NCC Infrastructure
Execution of the work	Renesco GmbH
Designer/ Engineering	Wingård architects
Construction Period	2021-2022

Project Description

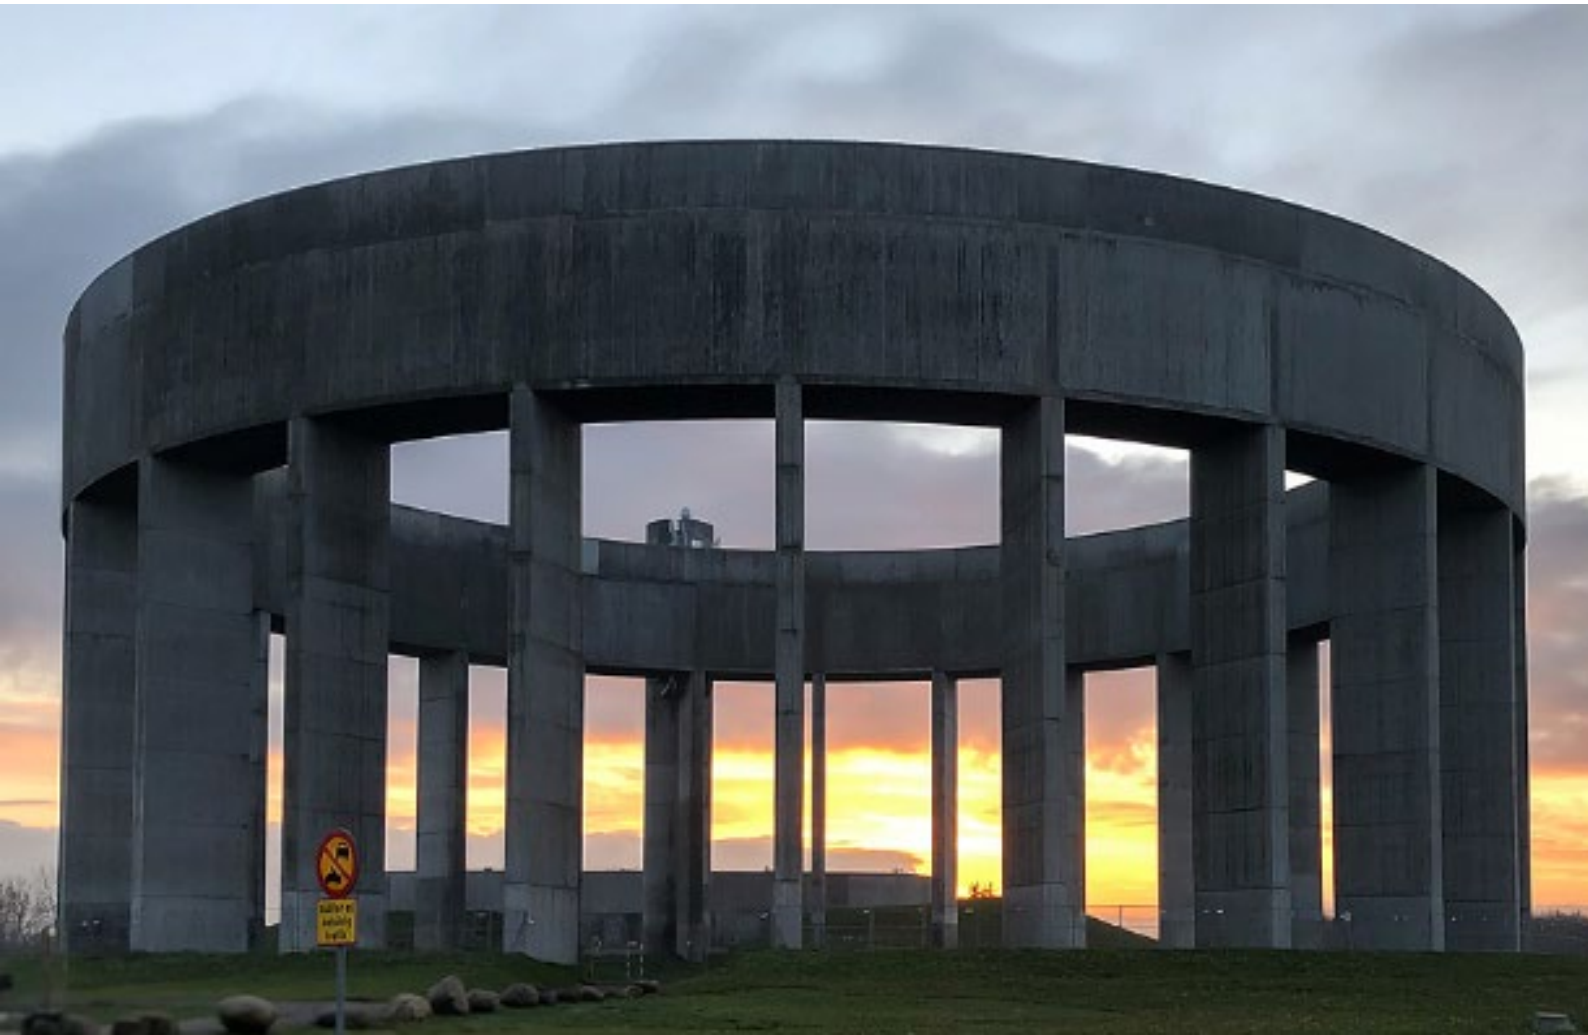
The new water tower was built to secure future water distribution in north-west Skånea and has a pioneering design like a modern aqueduct. Helsingborg's existing water tower in Fredriksdal, built in 1962, will remain in use even once the new water tower is operational. In addition to the water tower itself, the assignment also includes two service reservoirs and a technical building. The water tower is 40 meters high and consists of a reservoir in a ring (outer and inner tank), holding 7'000 cubic meters of water on top of 24 pillars in a circle with a diameter of 90 meters.

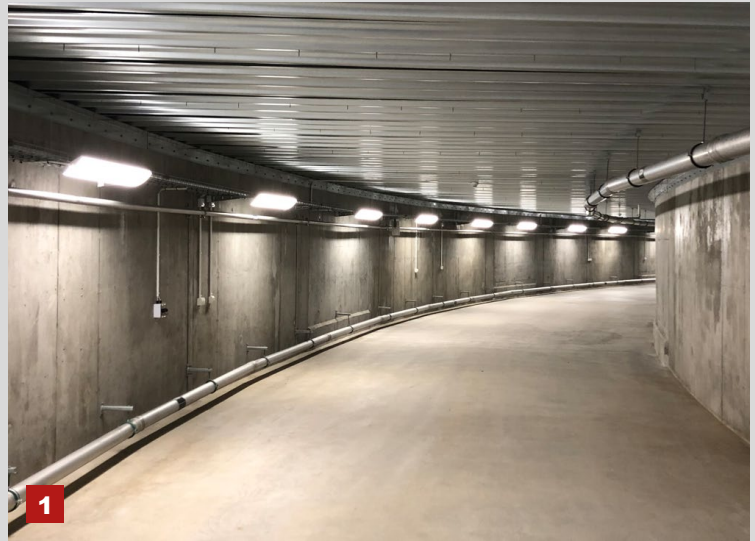
1. Floor on the upper level
2. Tank inside
3. Loose-flange connection

- Full surface & seam inspection via spark testing (electrical high voltage), vacuum and mechanical (hook) testing.
- Partly replacement of the existing waterproofing membrane, seams, and fixations
- Additional extrusion seaming/ welding
- Loose-laid steel clamping/ flanging
- Watertight test
